HASTELLOY[®] HYBRID-BC1[®] alloy

Iso-Corrosion Diagrams

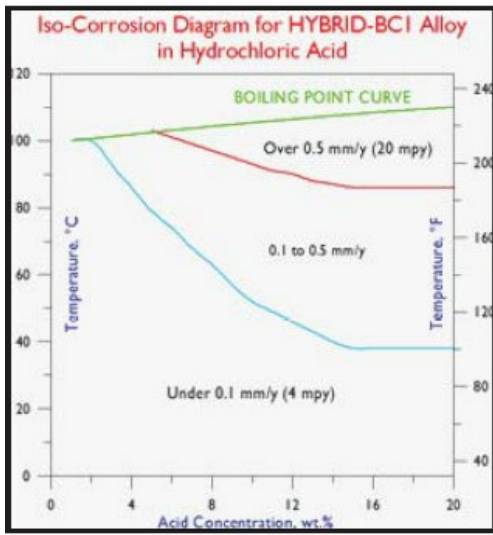
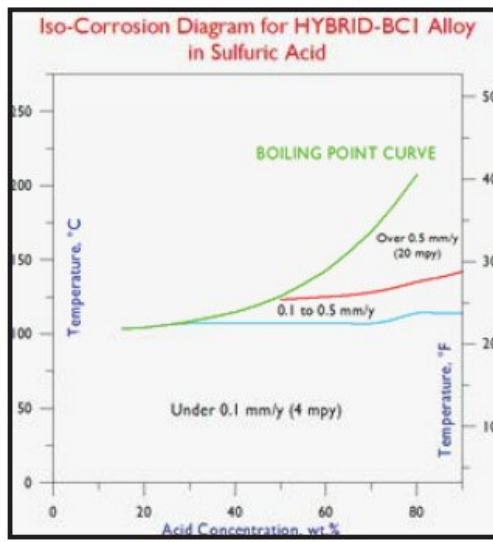
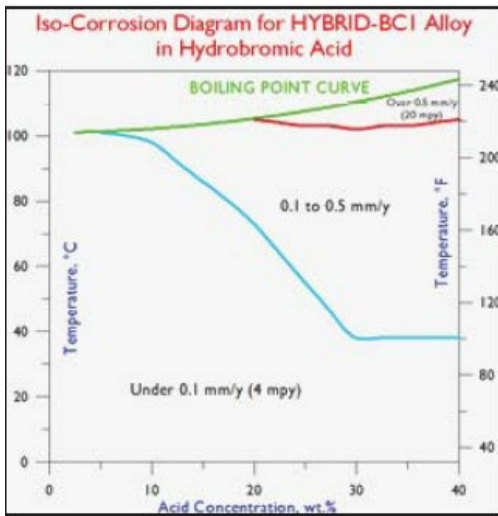
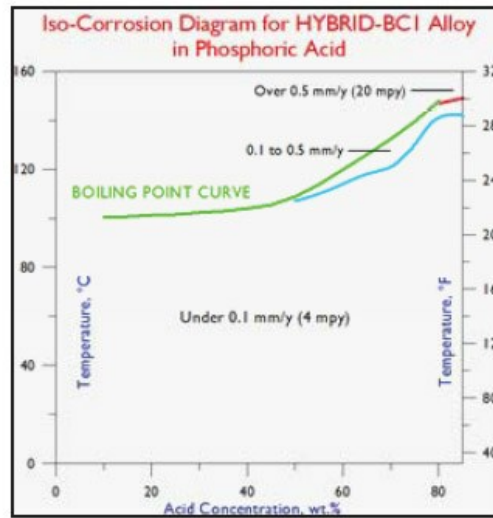
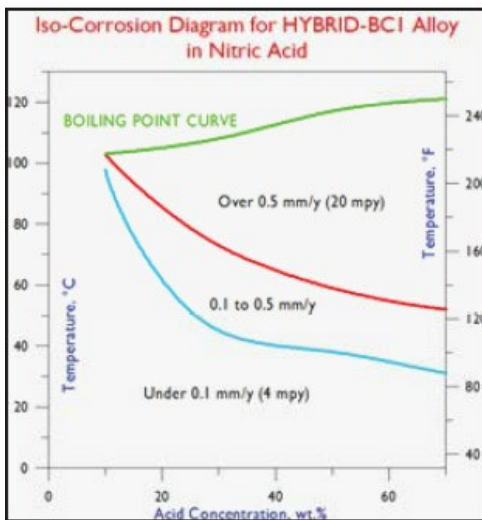
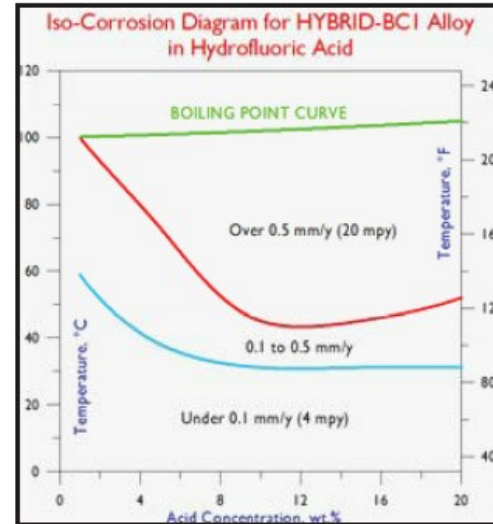
Each of these iso-corrosion diagrams was constructed using numerous corrosion rate values, generated at different acid concentrations and temperatures. The blue line represents those combinations of acid concentration and temperature at which a corrosion rate of 0.1 mm/y (4 mils per year) is expected, based on laboratory results. Below the line, rates under 0.1 mm/y are expected. Similarly, the red line indicates the combinations of acid concentration and temperature at which a corrosion rate of 0.5 mm/y (20 mils per year) is expected. Above the red line, rates of over 0.5 mm/y are expected. Between the blue and red lines, corrosion rates are expected to fall between 0.1 and 0.5 mm/y. The iso-corrosion diagram for hydrofluoric acid should be used with caution. Internal attack of nickel alloys is common in this acid; thus field tests prior to industrial use are even more important. Also, while HYBRID-BC1 alloy possesses useful resistance to nitric acid, stainless steels are generally preferred to nickel alloys in pure nitric.
